Environmental Assessment for Rehabilitation of Acequia del Barranco Rio Arriba County, New Mexico

DACA47-97-D-0009 Delivery Order 14

DECEMBER 2003

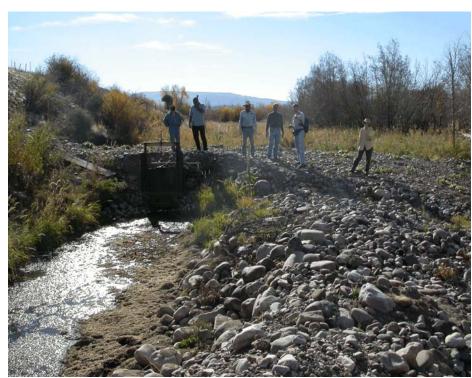
Photograph A-1. Existing Heading and Intake of the Acequia del Barranco (Point #1 in Table A-1)

The proposed project consists of two components. The first component would be replacement of the intake structure or heading (**Photograph A-1**), which is approximately 60 feet downstream from the diversion dam in the acequia channel. The new structure would consist of a concrete-capped gabion headwall with a headgate connected to a 20-foot long (57" by 38") arch pipe. A debris deflector and a trash rack would be installed on the upstream side of the headwall. The channel at the outlet of the pipe would be stabilized with 4"- to 12"-inch cobbles and any disturbed ditch banks would be graded to at least 1.5:1 slopes.

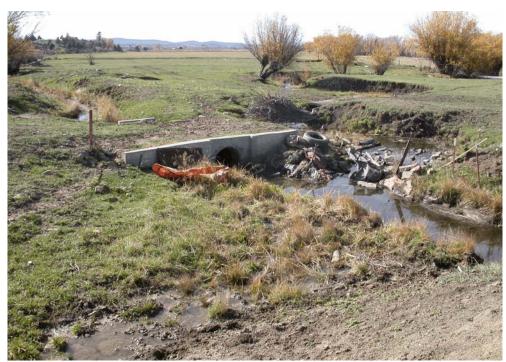
Photograph A-2. Existing Water Control Structure at Sawmill Arroyo Proposed for Rehabilitation (Point #16 in Table A-1)

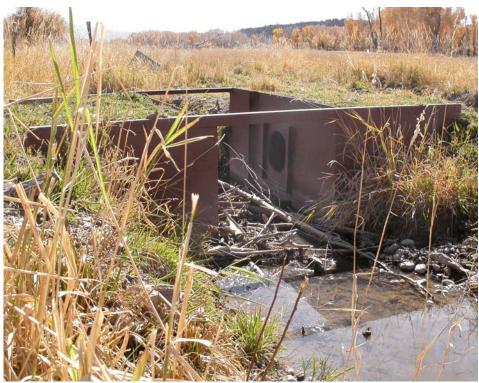
Photograph A-5. New Metal Modular Check/Tap Structure

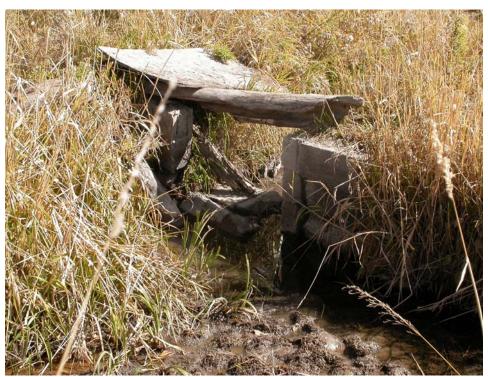
Photograph A-6. Older Concrete Check with Wooden Gate

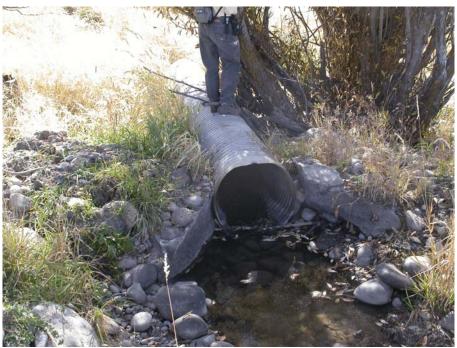
Photograph A-7. Full-round Metal Flume Spanning Small Arroyo

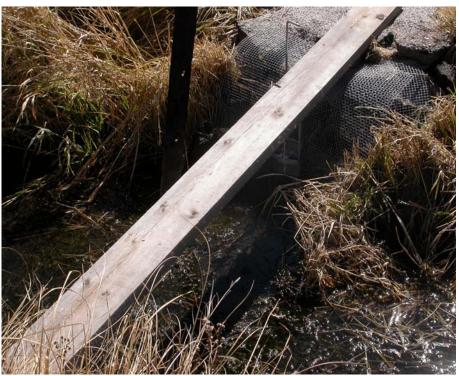
Photograph A-8. Footbridge with New Modular Metal Tap

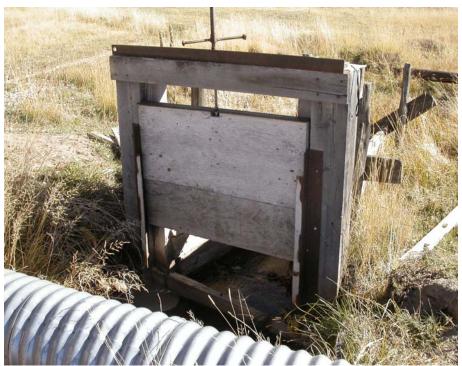
Photograph A-9. Older Wooden Check below a Crossover Flume

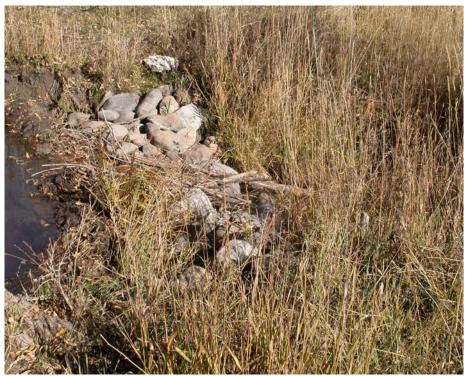
Photograph A-10. Rock Drop Structure at Change in Acequia Gradient

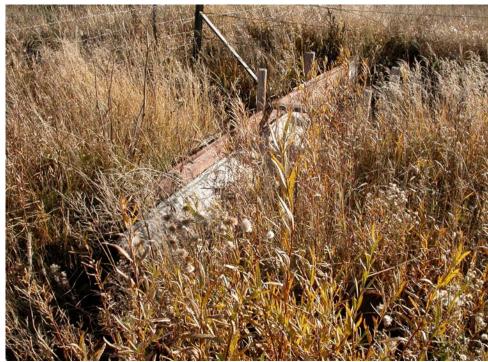
Photograph A-11. Boxed Wooden Flume Toward End of Acequia
